WASHINGTON STATE MAJOR LEAGUE BASEBALL  
STADIUM PUBLIC FACILITIES DISTRICT

# SAFECO FIELD LONG-TERM CAPITAL NEEDS ASSESSMENT

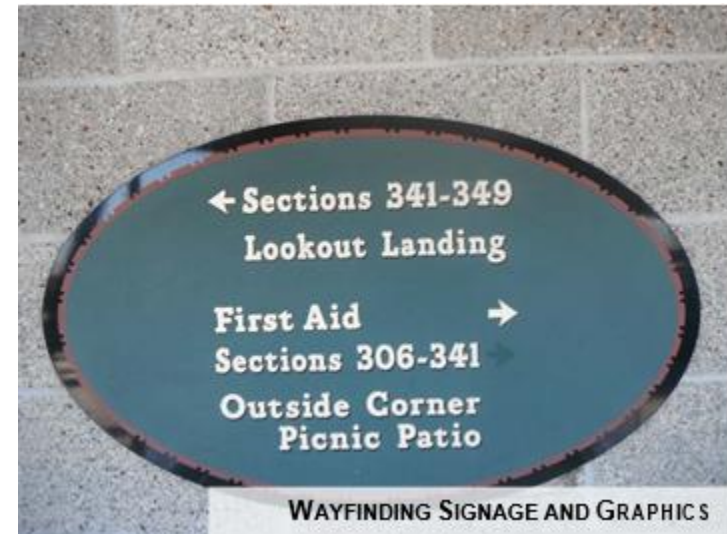
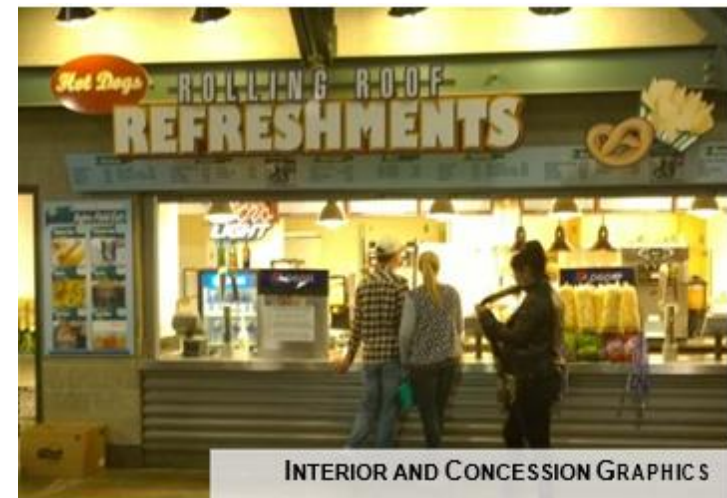
➤ **SG 2.1: EXTERIOR SIGNAGE**

Exterior signage is original and showing wear. As such, it will need to be updated to reflect a more contemporary feel and look.

Program a modernization of the exterior branding and signage in conjunction with an update to the interior and concession graphics improvements.

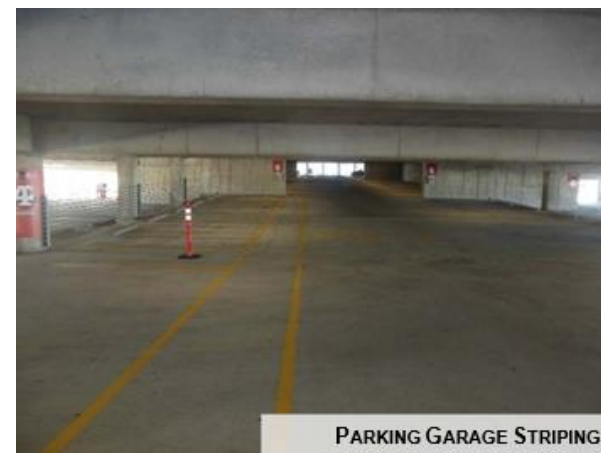
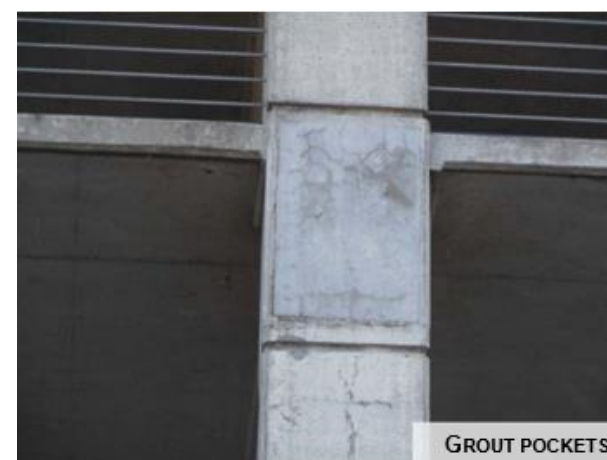
▾ **G 4.0: PARKING GARAGE RENEWAL & REPLACEMENT**

The parking garage has historically needed approximately \$75,000 annually in capital investments. These investments have included expansion joint repair, signage, and cameras. The garage will likely need similar investments moving forward, most of which are not identifiable at the time of this assessment.

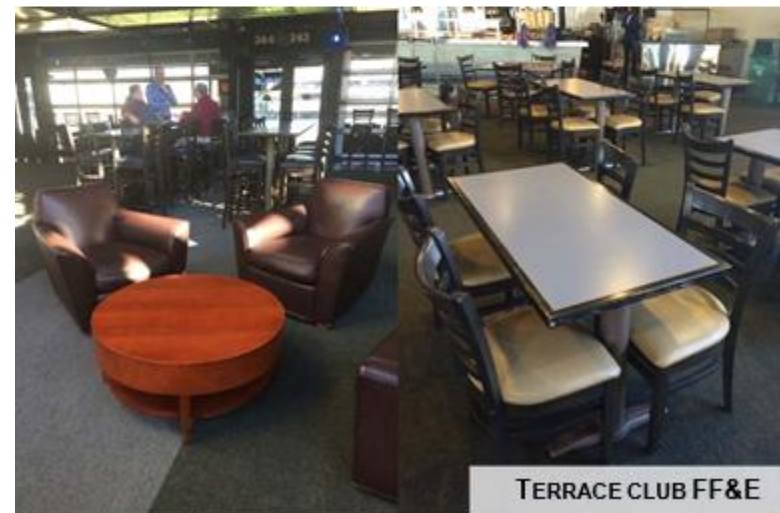
TERRACE CLUB FF&E

The Terrace Club contains over 4,600 seats on the 200 level. Each club seat holder is provided access to adjacent lounge areas on the first- and third-base sides of home plate. The adjacent lounge finishes, such as the flooring and woodwork, are very basic and have an industrial feel. Furniture is a mixture of high-top tables and other basic furniture.

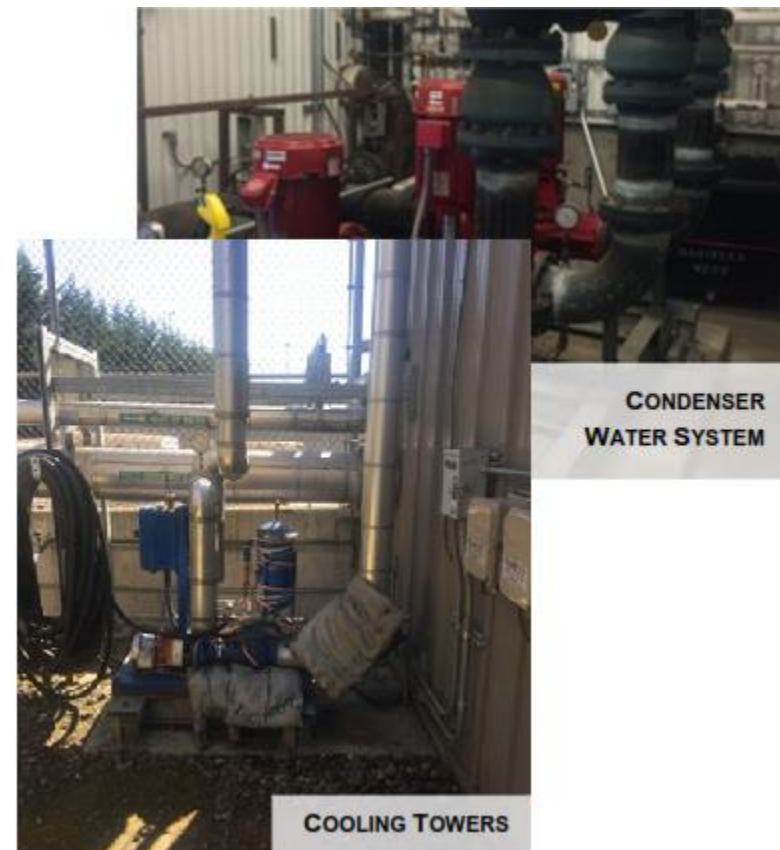
The condenser water distribution systems consist of plate and frame heat exchangers between the condenser water loop and the open cooling tower loop, system pumps, and distribution piping. The pumping system is an N+1 design (redundant pumping system), and staff indicated that at times they have run all pumps simultaneously to maintain system pressure.

As part of the study recommended in M1.0, the distribution system should be analyzed for future capacity. Replacement of the pumps will be needed within the next five years.

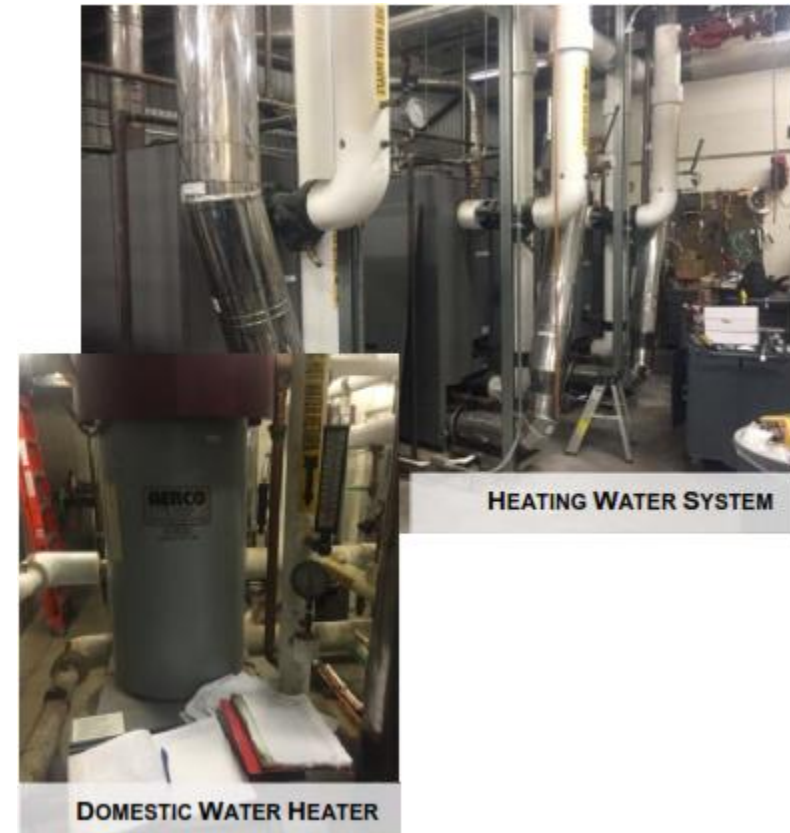
Plumbing components and sub-systems will need replacement throughout the duration of the plan, including piping for water, gas, and circulation, and replacement of fixtures and fire protection equipment.

Develop a replacement and renewal plan to address component failure and equipment replacement based on historic levels of investment.

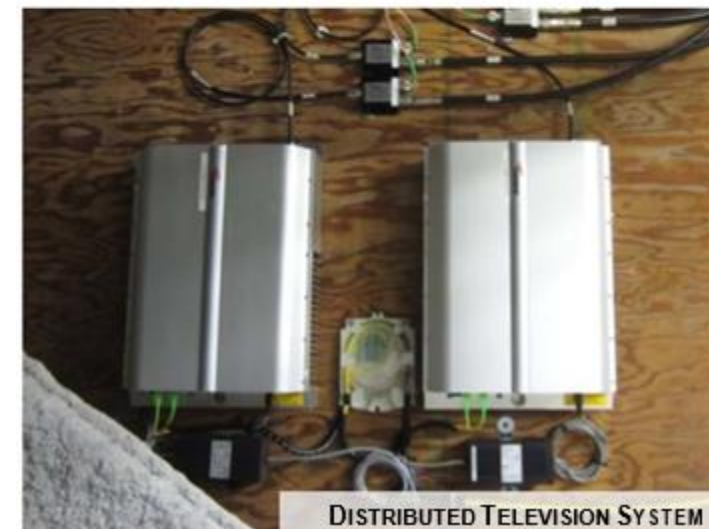
The broadcast cabling infrastructure is as originally installed and needs significant overhaul. Coax video cabling is obsolete and its presence in the facility will hinder the implementation of new technologies in the near future.
